EXHIBIT D

**IN THE HIGH COURT OF FIJI AT SUVA
CIVIL JURISDICTION**

Civil Action No. HBM No. 57 of 2022

AFFIDAVIT OF [REDACTED]

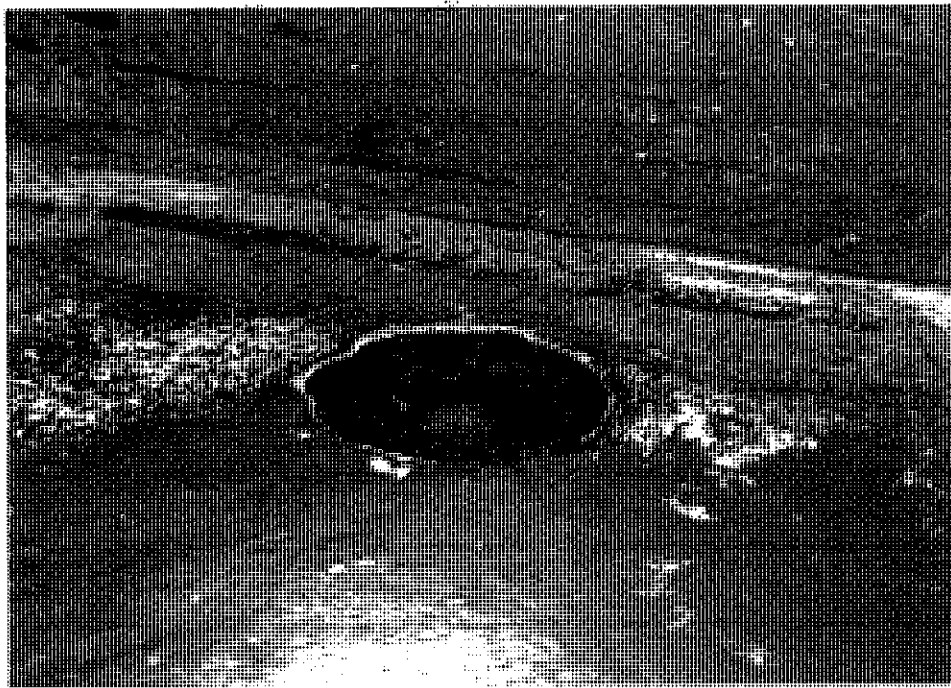
10. I hope the above gives a snapshot of the maintenance required. Our system has a total of 675 jobs recurring on calendar and running hours basis.
11. In addition to the above is the issue with the large pitting found in ballast tank VIA2 needs to be addressed. The pit is measuring approx. 8-9mm deep and approx. 30mm in diameter and it is unclear how much metal is left. Ship construction diagrams show the steel in this area to be 9mm so the remaining steel will be wafer thin.

12. I have an ultrasonic tester arriving on Saturday which will allow me to measure the remaining steel but given my experience from the dry dock last year, Lloyds Register will almost certainly request the vessel to be dry docked and the steel replaced.

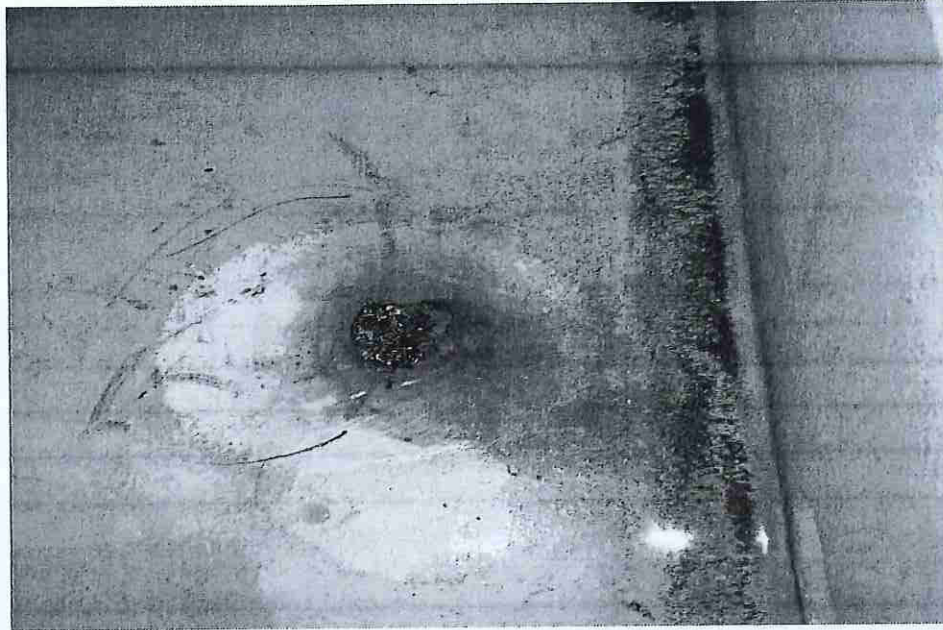
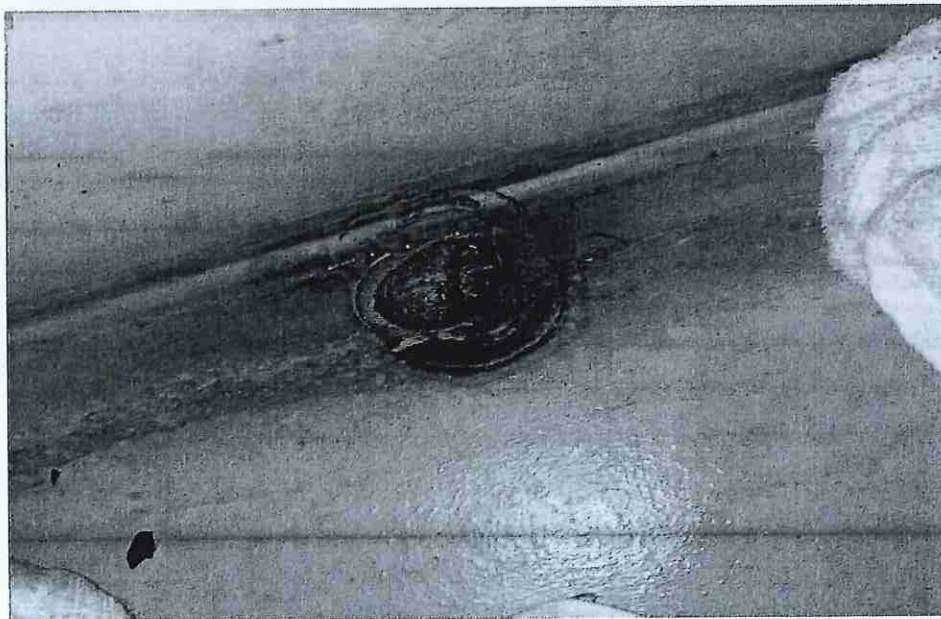
13. Below are pictures of two pits found in Ballast Tank VA1 last year and at the time Lloyds Register insisted that a plate measuring the size of (1000mm x 300mm) that was inserted into the ship's hull. The two pits found then were significantly smaller than the one currently in VIA2:

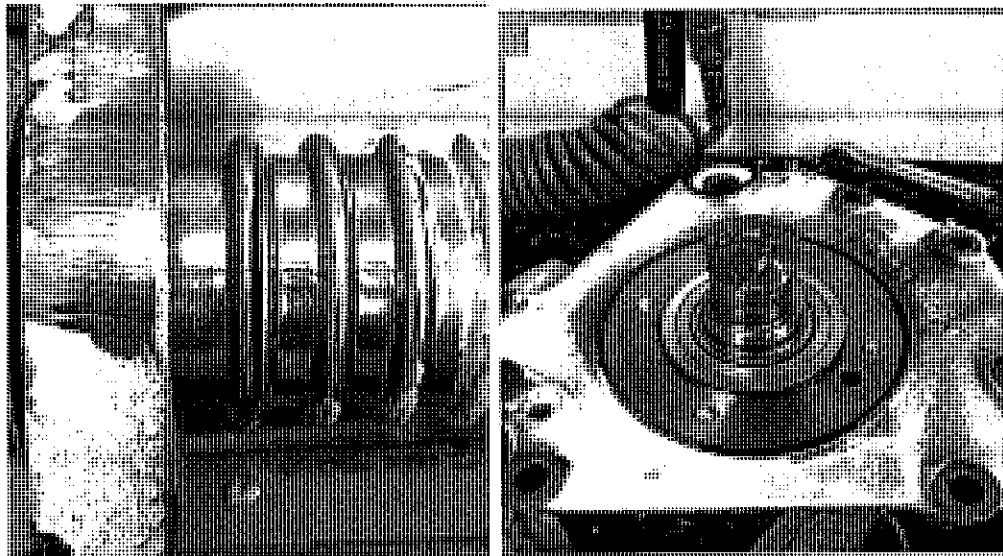
14. We have had several failures on previous passages including the Starboard main engine sea water pump which suffered catastrophic mechanical failure on passage in March 2020 and the failure of a turbo charger oil line which resulted in hot oil being sprayed onto the Port main engine exhaust manifold, also in March 2020:

15. Only the vigilance and actions of experienced crew, who are very familiar with onboard procedures and systems prevented these two incidents becoming disasters. The failure of the turbo charger oil line could easily had led to a major fire had it not been dealt with in a speedy and efficient manner. A failure like this has caused many fires onboard vessels over the past number of years.
